Navajo Abandoned Uranium Mine

Site Screen Report

Cisco Mine AUM Site

March 2010

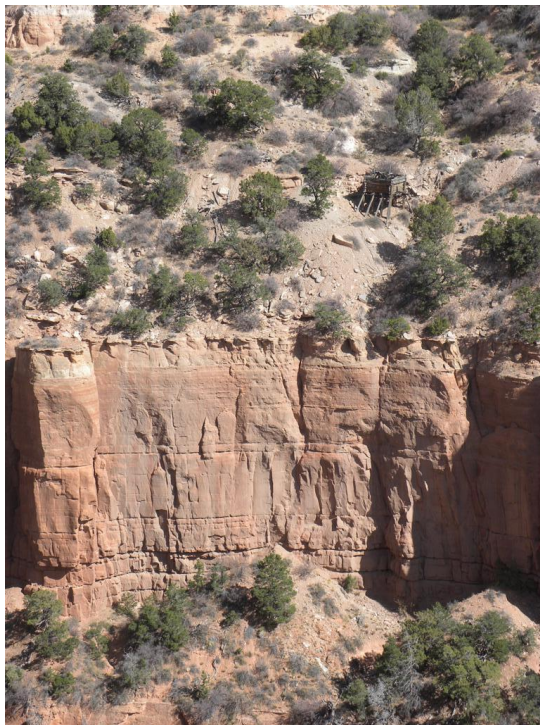
Photo 1. Mine site from across ravine

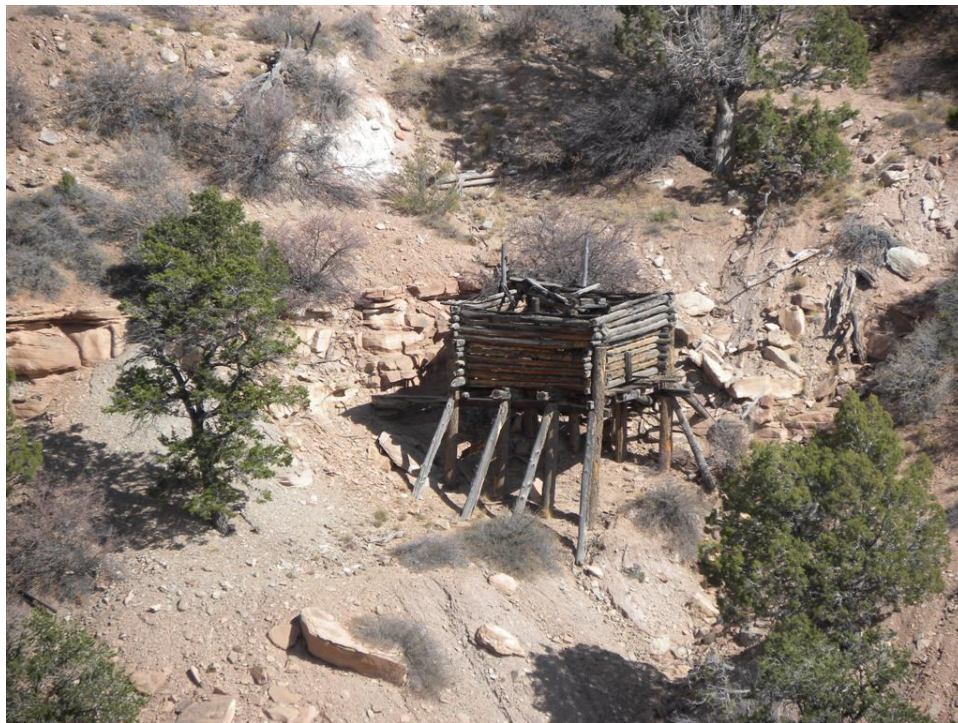
Waste pile below wood structure 75' x 75', with a total estimated volume of 1,042 yd³

Photo 2. Wood structure and waste pile below

Unreclaimed waste pile, exposed yellow rock immediately east of site with elevated radiation measurements

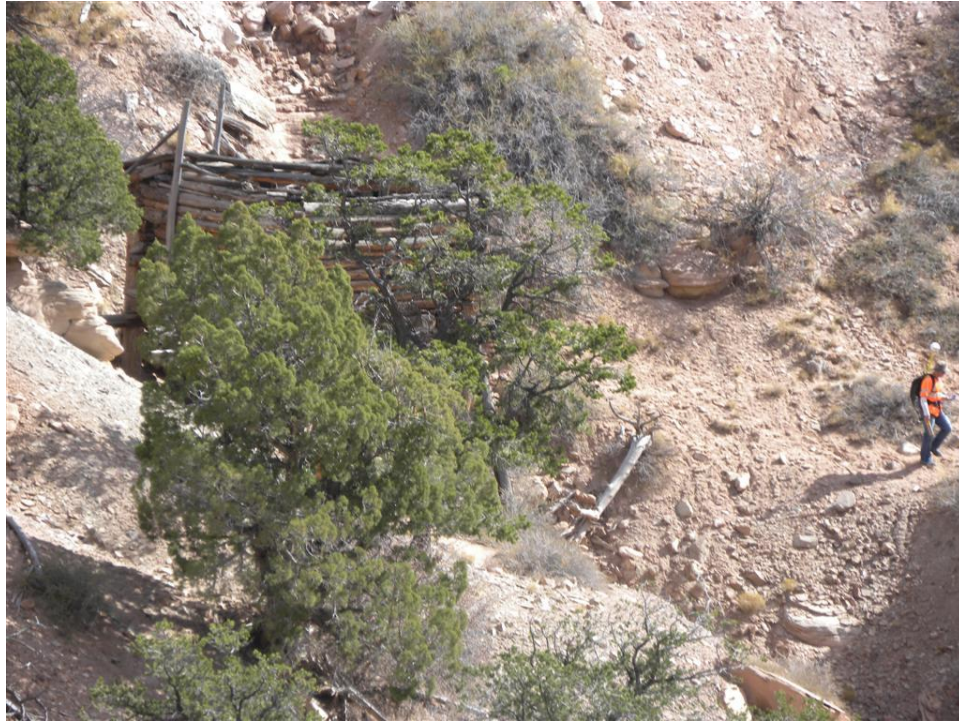
Photo 3. Wood structure and waste pile below

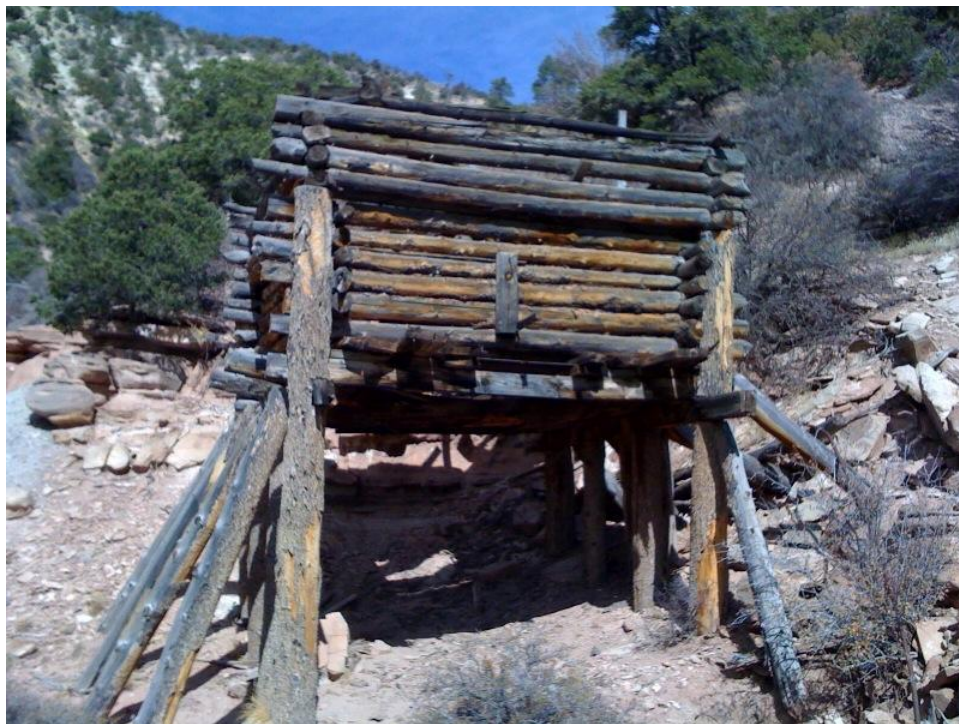
Photo 4. Wood structure and waste pile below

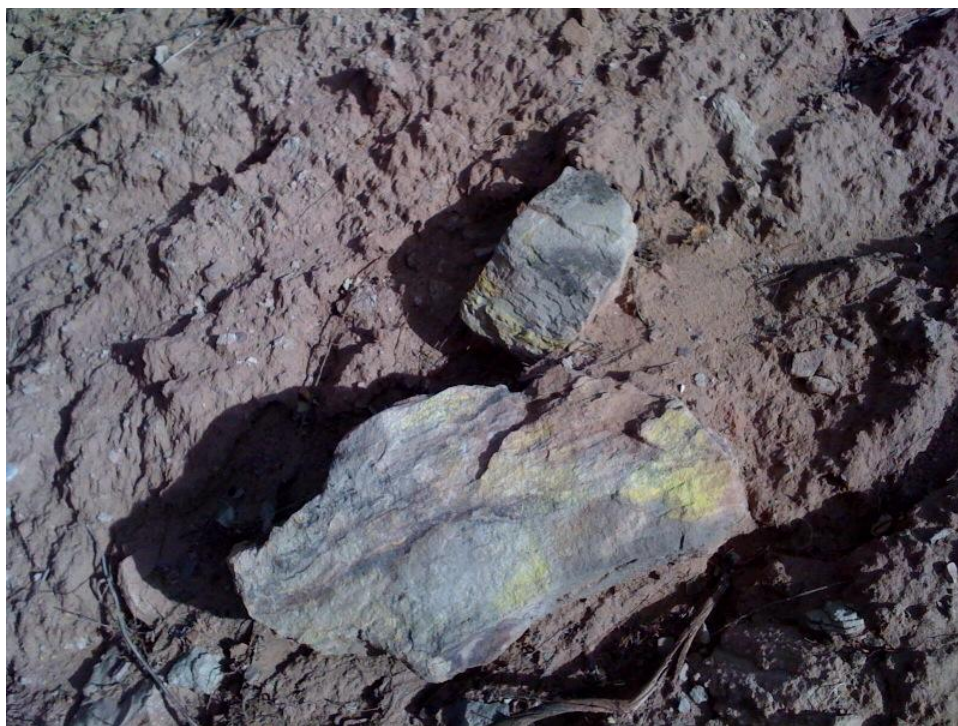
Exposed yellow rock immediately east of site with elevated radiation measurements

Photo 5. Exposed yellow rock
